CHARACTERISTICS OF MICRO-DRAINAGE SYSTEM AND ITS ENVIRONMENTAL IMPLICATIONS IN URBANIZED TROPICAL CITY OF ILORIN, NIGERIA

Kayode IROYE*

Department of Geography and Environmental Management, University of Ilorin, Nigeria,
e-mail: kayodeiroye@gmail.com

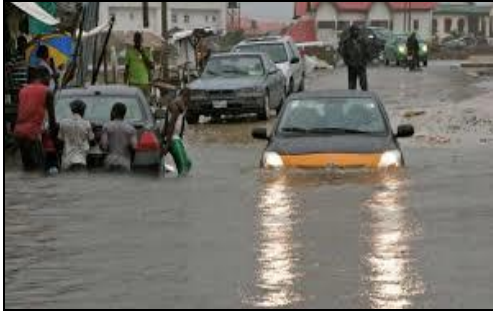
Figure 3. Flood Situation in Ilorin

Apart from the above described climate change induced problem of drainage infrastructure in the study area, urbanization process is also presenting a challenge. Ilorin, the study area is undergoing rapid urbanization process since it became a state capital in 1967. Oyegun (1987) observed the built-up area in the city to have grown from 20.40 sq. km in 1963 to about 58.00 sq km in 1982. By 1997, the area occupied by artificial paved surface in the city has increased to about 150 sq km with consequent effect on runoff generation. Urbanization process is one of the anthropogenic distortions to the theoretical operation of the hydrological cycle. According to Jones (1997), its greater consequence on catchment runoff pattern is as a result of paved surfaces. Increase in urban development usually results in reduced infiltration, increase in volume and rates of runoff discharge and reduction in lag time due to increase in velocity of overland flow (Hall, 1984; Roel, 1984). And with constricted nature of drainage system as observed in this investigation, the resultant effects are flooding, pollution, erosion, sedimentation amongst others. The total capacity of drainage networks at construction in the study area was 36,646.71 m³ and a mean value of 718.56 m³. However, the current total capacity of all the drainages is 23,267.40 m³ and a mean value of 456.22 m³. This thus shows that the total capacity of all the drainage networks in the study area has dropped by 13,019.31 m³ which represent 35.53% reduction in carrying capacity. This reduction in carrying capacity is basically due to reduction in depths of the drainage channels caused mainly by anthropogenic activities. As a matter of fact, the percentage reduction in carrying capacity of two of the drainage networks examined in this study (i.e. Garin Alimi – Sawmill and Sawmill – Queen School) is 100%. This is because the two drainage networks have been completely filled up with sands and other waste materials. Three of the drainage networks (i.e. Airport – Garin Alimi, Government House Roundabout – Fate Roundabout and Admiralty Villa Road) however recorded very low (<10%) percentage reduction in carrying capacity. The tree drainage channels only recorded 0.4, 6.67 and 9.84% reduction in carrying capacity respectively; thus they can be regarded as being fairly clean of wastes and sand. The field result on these three drainages networks is understandable, Airport – Garin Alimi drainage channel is the deepest and widest in the study area. The drainage channel because of its dimensions of width and depth is thus able to transmit any load deposited into it easily as the competence is very high due to the amount of water it carries. The other two drainages are located in Government Reserved Areas where population density is very low. Not only that, much of the land area draining into the two drainages are covered by lawn, especially the Admiralty Villa Road drainage channel which drains runoff mainly from a Golf court.

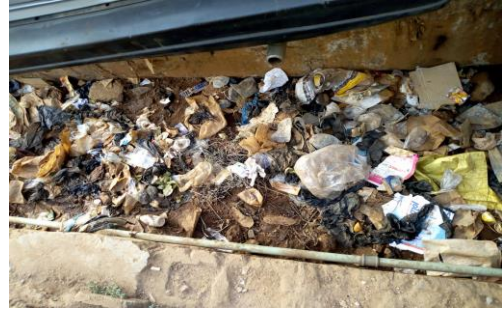
Figure 4. Solid Wastes in Drainage

As a result of urban growth accompanied by high population density, waste generation and disposal has become a serious environmental concern in the study area as can be seen on figure 4. It is this particular factor that can be largely held responsible for the high degree of sedimentation in the drainage channels examined. Generally, the nature of sediments found in the drainage channels in the study area can be categorized into eight; such includes plastics, polythene nylon, metals, glass, sand and stones, leaves, wood, and other miscellaneous materials such as cloths, food and animal remains. As can be seen on figure 5, the percentage composition of the sediments however vary significantly with sand and stones accounting for more than 65% while polythene nylon accounted for 11.71%.

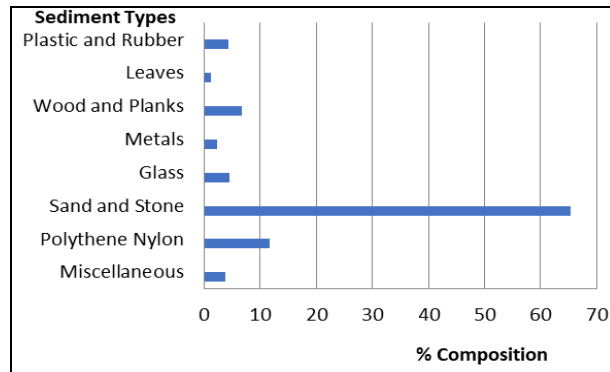
Figure 5. Percentage Composition of Sediments in the Drainage Channels

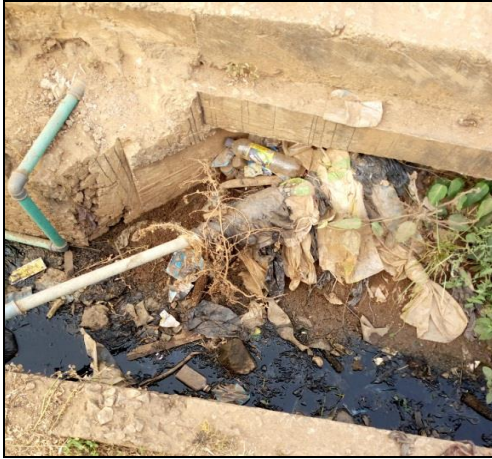
Figure 6. Storm Flow Obstruction by Utility Lines

The enumerated waste materials find their way into drainage channels due to peoples’ poor attitude towards refuse disposal. It is even not uncommon to find people directly dumping their wastes into flowing water whenever it rains in the study area (Jimoh 1994; Iroye, 2008; Iroye, 2013). While lightweight materials such as plastic and rubber, leaves, polythene nylon, and wood thrown into micro drainages flow into the main rivers when runoff volumes are high, these materials stop moving when rain ceases, thus causing debris pile-ups which obstruct the movement of subsequent storm flow. The dumping of heavy materials such as stones and metal debris into moving water reduces channels depth, affect drainage competence to carry load; hence the high sedimentation values observed in the studied channels. In some places, utility lines such as water pipes were found obstructing storm flow as they are laid across the drainage channels (figure 6) while in other places, the drainage channels have been overgrown by vegetation (figure 7). Both utility lines laid across drainage channel and vegetation growth within a channel serve as clog, preventing the free movement of solid wastes within drainage channel, thus encouraging sedimentation.

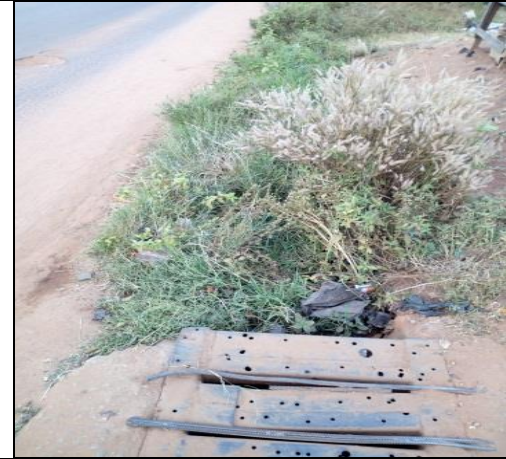
Figure 7. Drainage Channel Overgrown by Vegetation
